Forensic Report Accident Uber-Volvo 18.03.2018 (Extract from Research Project Car-Forensics)

DigiFor Inside 04-2018

Forensic Report Accident Uber-Volvo 18.03.2018 in Tempe, Arizona (USA)

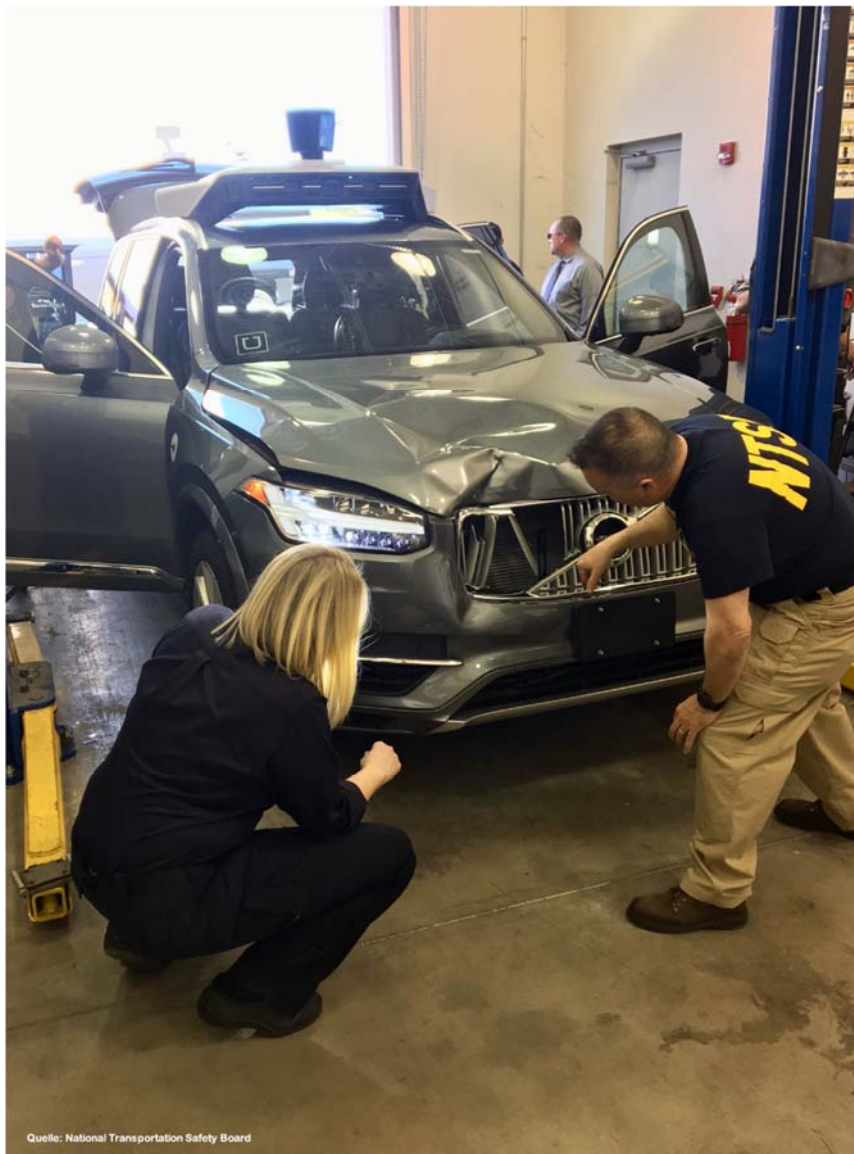
Illustration 1: Accident vehicle in the investigation by police and specialists

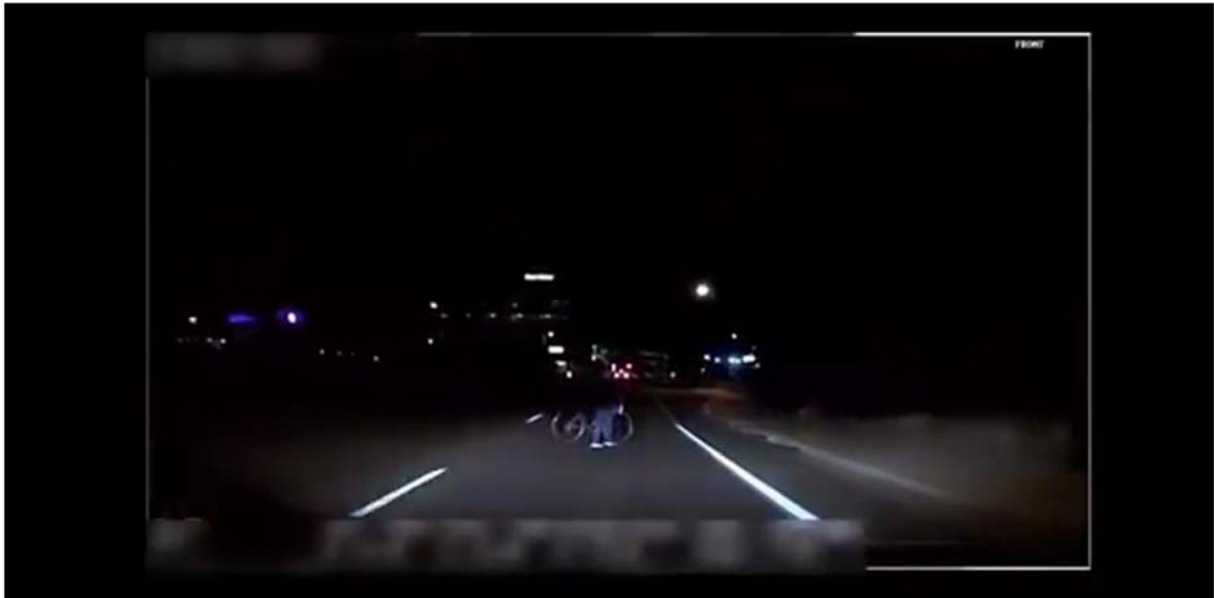
It is particularly noticeable after a first sighting of the video material freely available on the Internet about the crash that the picture of the front camera is very dark and the pedestrian actually seems to emerge from the shadow just before the collision. This initially nourishes the thesis that the accident would have been unavoidable even for a human driver:

Illustration 2: Cutout Dashcam video (source YouTube - resolution 636 x 360 px)

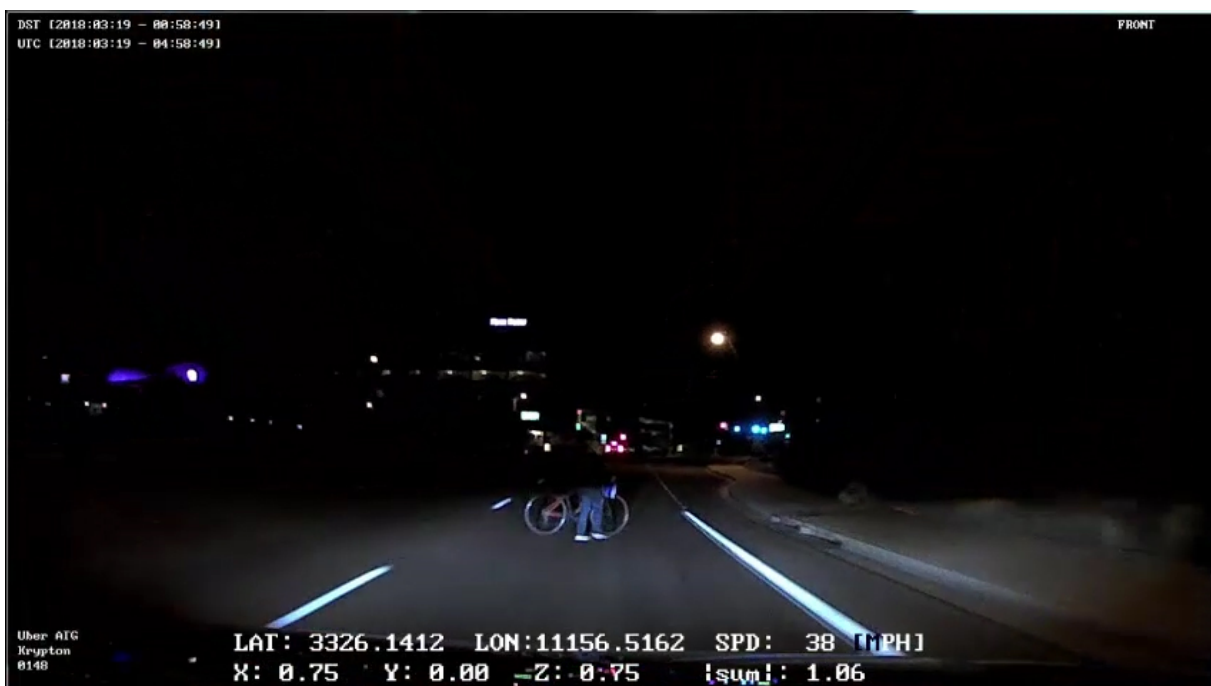
Illustration 3: Cutout Dashcam video (source police Tempe - resolution 848 x 480 px)

Unlike the shortened video on YouTube, the video starts sooner (just before the bridge is undercut), so important details become visible for further analysis.

First, it is striking that the interface between the outside and inside view and at the end of the video briefly, the background image of the Windows Media Player is visible. If one compares its quality (and brightness) with that of a screenshot on the author's evaluation PC after playing the original video, one recognizes that the latter is qualitatively clearer and a little brighter. This leads to the conclusion that the police has not evaluated the original video from the vehicle or distributed, but this was recorded and cut from a PC presumably using a screen recorder. In the process and the subsequent export of the edited video material, it seems that there has been a loss of quality. It is even conceivable that the original video was filmed with a video camera or a smartphone. That would then be an extremely negligent and unprofessional procedure with regard to the evaluation.

Extremely questionable is why not the digital output file was used in the highest possible resolution. One could assume that the video was deliberately played on a PC and this brightness or quality reductions were deliberately or at least negligently accepted.

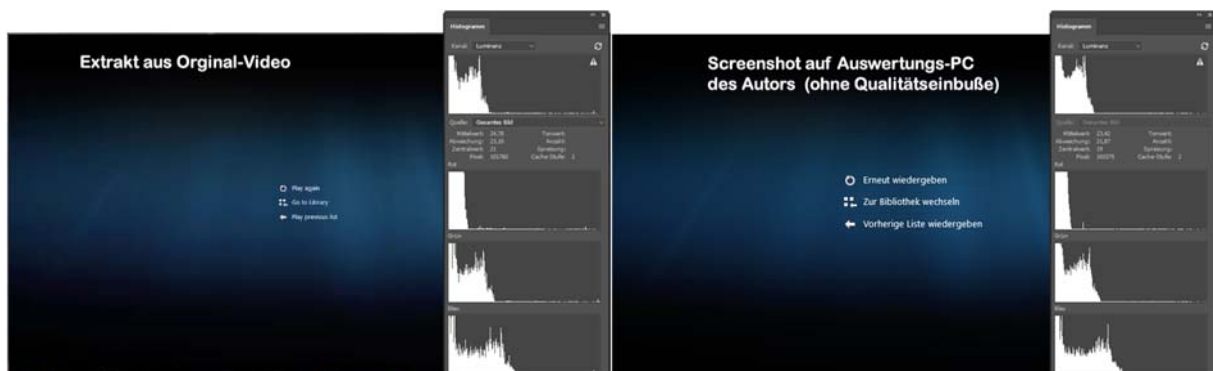
Illustration 4: Compare reduced quality police video to possible resolution / brightness

The histograms show the slightly higher dynamics of the screenshot (right) with less noise compared to the video provided by the police (left).¹⁰

Should the video still depict the real lighting conditions 1:1, this would in turn mean that the visibility has reached only to the limit of the driving light (here dipped beam). Since you can only drive so fast that you can stop the vehicle at any time within sight, this would mean that you would have to drive much slower in these light conditions. The visibility can be measured on the median strip in the video and the comparison with Google Earth to about 25 m. This in turn leads to a maximum permissible speed of 45 km / h (equivalent to 28 mph) for conventional assumptions (1 s reaction time, 6 m / s² deceleration on dry asphalt)¹¹.

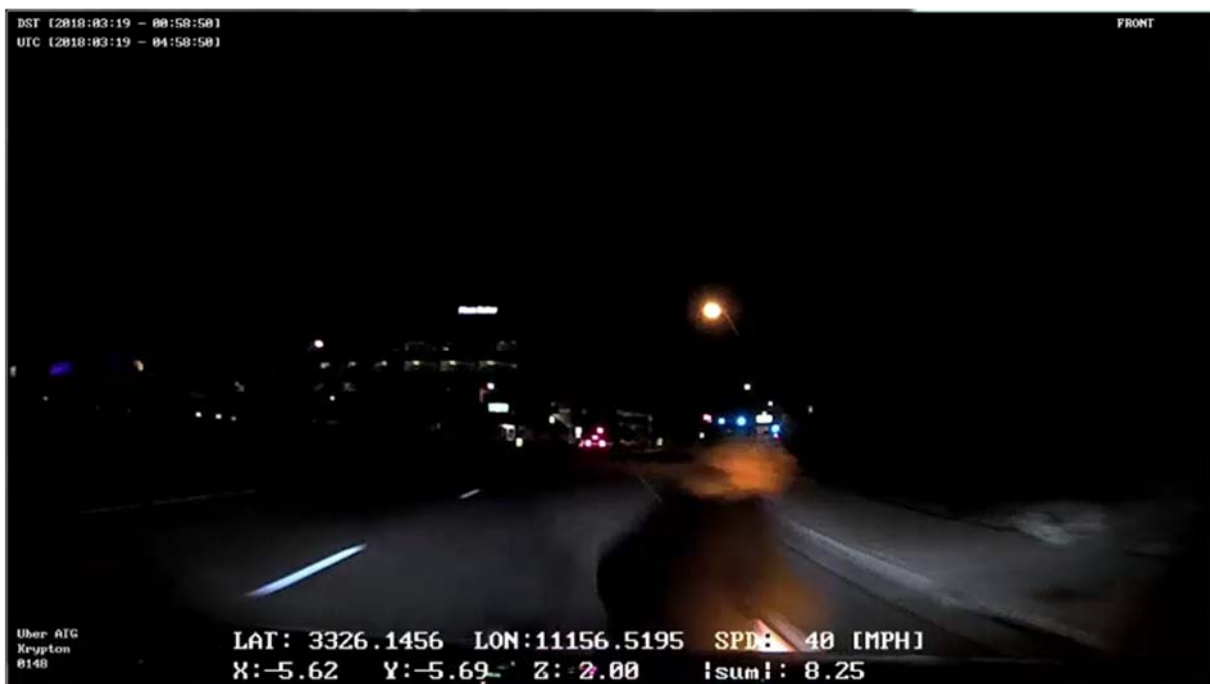
From the metadata contained in the image border one can read off further information and further process it for the evaluation. Thus, the time stamp shows that the accident took place on 18/03/2018 at 04:58:50 UTC (corresponds to 00:58:58 local time) in the geographic coordinates LAT 3326.1456 LON 11156.5195 at a speed of 40 mph¹³:

Illustration 6: Picture from the police video immediately after the impact

The values X, Y and Z presumably indicate the acceleration in the longitudinal and transverse axis or vertically downward (gravitational acceleration) and the value "sum" is used to determine a vector sum (mathematical magnitude) for the resulting acceleration. At 8.25 m / s² this value is significantly higher than the normal values during a journey and indicates the impact.

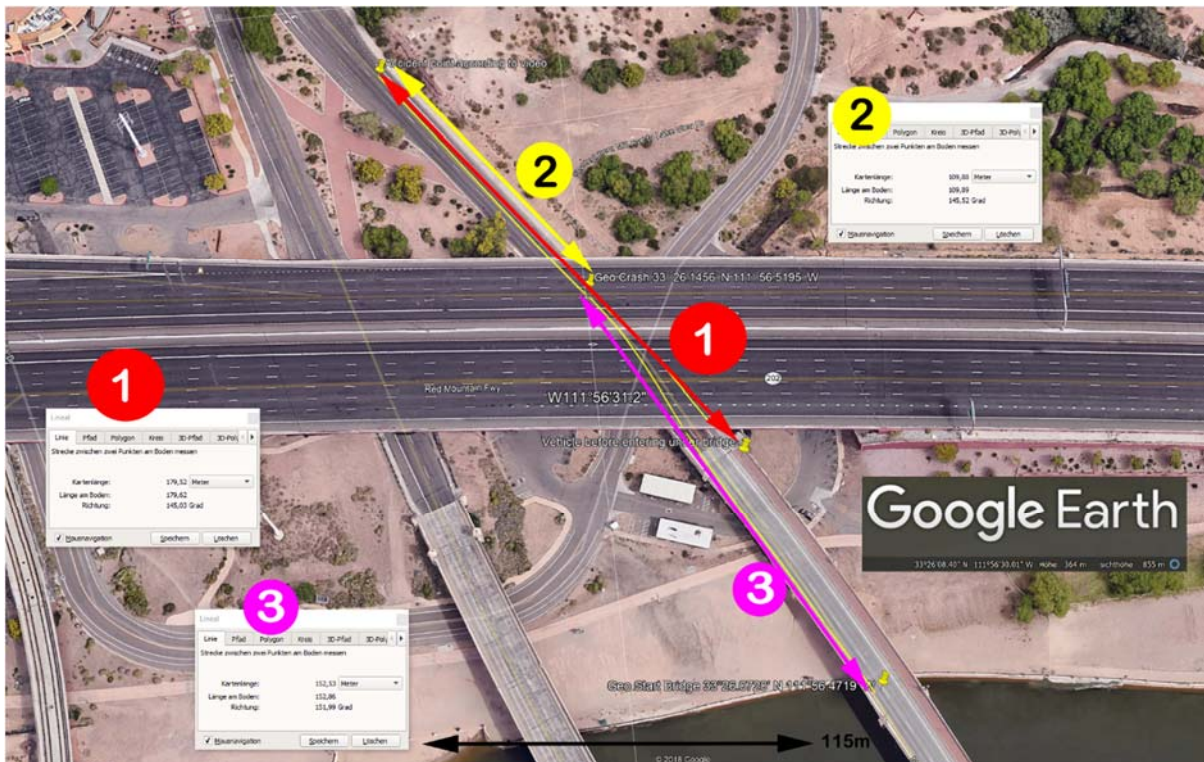
If one interprets the values as degrees, minutes, seconds and in this case the seconds as a decimal value, this leads to 33 ° 26 '14.56' 'N 111 ° 56' 51.95 " W. These values lie about 500 m away from the actual accident location. This is significantly more than the usual error of the GPS signal of less than 15 m.

However, if you interpret the values as degrees and minutes and the minutes as a decimal value with decimal places, this leads to 33 ° 26.1456 'N 111 ° 56.5195' W. This value is plausible because it lies on the vehicle's travel path. However, the distance to the actual accident point at this time is approx. 108 m.

Illustration 7: Deviation alleged geo-position to actual position

Another test point was examined at the beginning of the video just before driving under the bridge. According to the video, the vehicle is at this time at 33 ° 26.0720 'N 111 ° 56.4719' W and actually about 76 m away from the actual position.

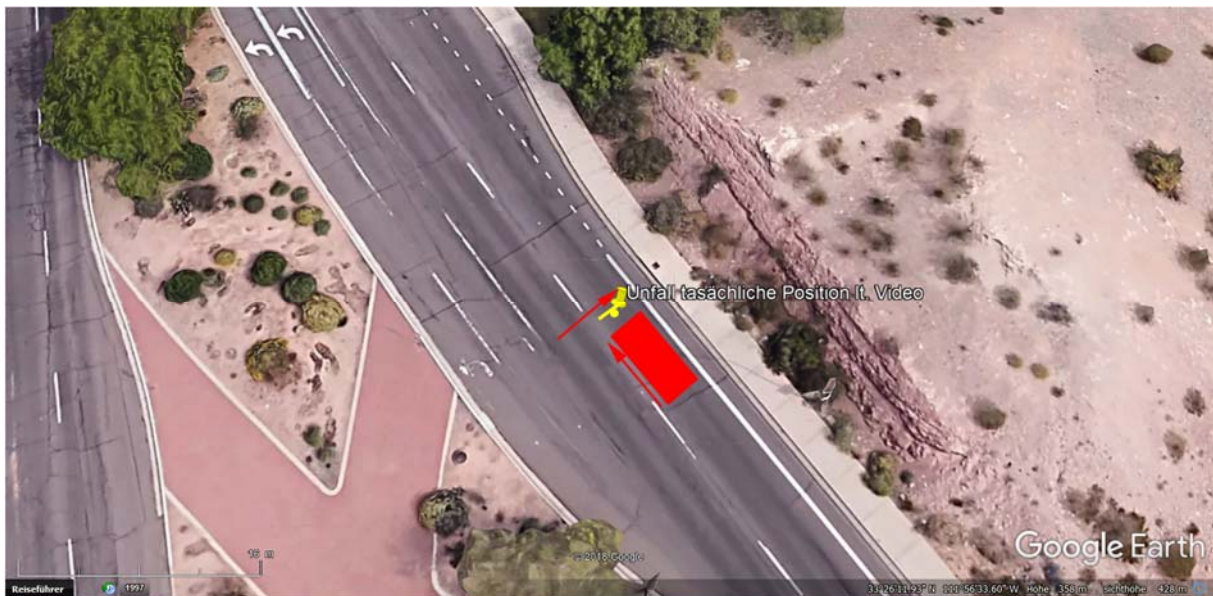
The metadata contained in the video should therefore be handled with the utmost care - also with regard to the presumed calculated speed. This obviously refers to the area before driving under the bridge. In this area, a speed limit of 35 mph applies up to the bridge, which makes the calculated value v_{Geo} of 34 mph plausible. The deviation or offset by approx. 76 m or 108 m on the driving beam is due to a delayed calculation of the speed based on outdated GPS data by a few seconds. The speed measured by GPS is always calculated from two previous geo positions and the time required for this. If the values are updated slowly, the thus determined speed always corresponds to that before x seconds. Using the video you can determine the coordinates of the impact very accurately by comparing the lane marking with the images from Google Earth:

Illustration 8: Mapping the accident using Google Earth

If one measures in the video the time, which needed the vehicle shortly before the accident for the departure of the distance of 6 middle trace marks, then this leads to a higher speed:

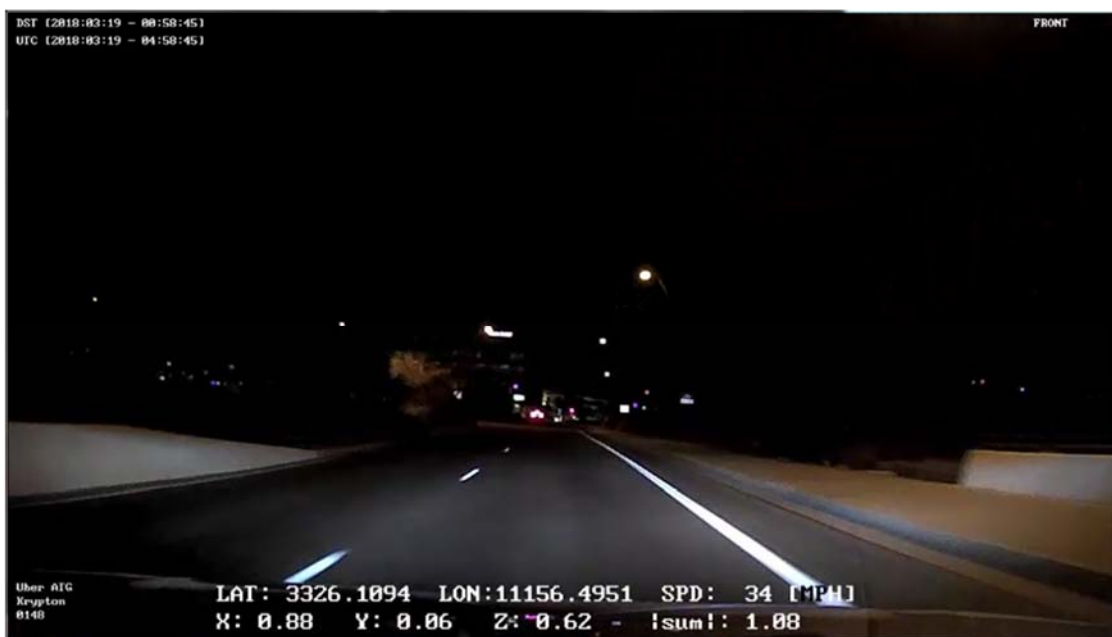
That means the vehicle has had a speed of about 45 mph in the last 70 m before the impact. According to the video (metadata), the vehicle accelerated in this area from 34 mph to about 40 mph directly on impact and then increased the speed to 42 mph after the accident. The latter is completely implausible, since that would mean that the car would have accelerated again when hitting the victim. In fact, it will have been slowed down by the impact. The findings on the previous page also explain this apparent contradiction. The speed values shown in the video, in contrast to the acceleration values X, Y and Z detected in real time, are outdated by several seconds and refer to the roadway about 76 m to 108 m further ahead of the accident. It is also plausible that the vehicle accelerated there, as the speed limit was raised from 35 mph to 45 mph from the time the bridge was driven under, as shown immediately.

Illustration 9: Front camera image about 120 m before the accident

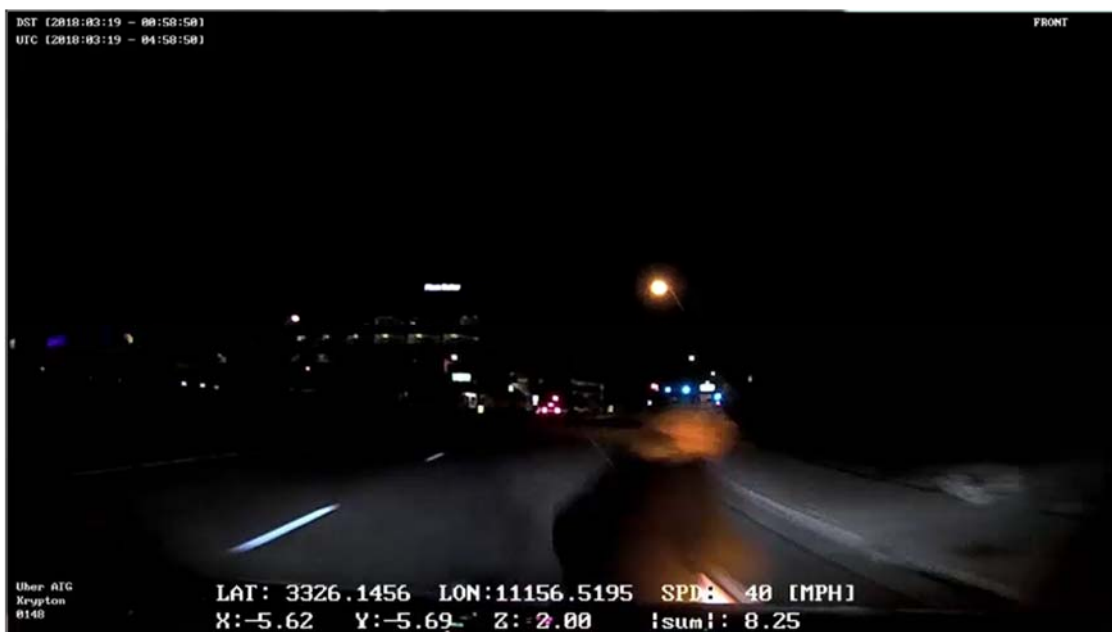
Illustration 10: Front camera image immediately after impact

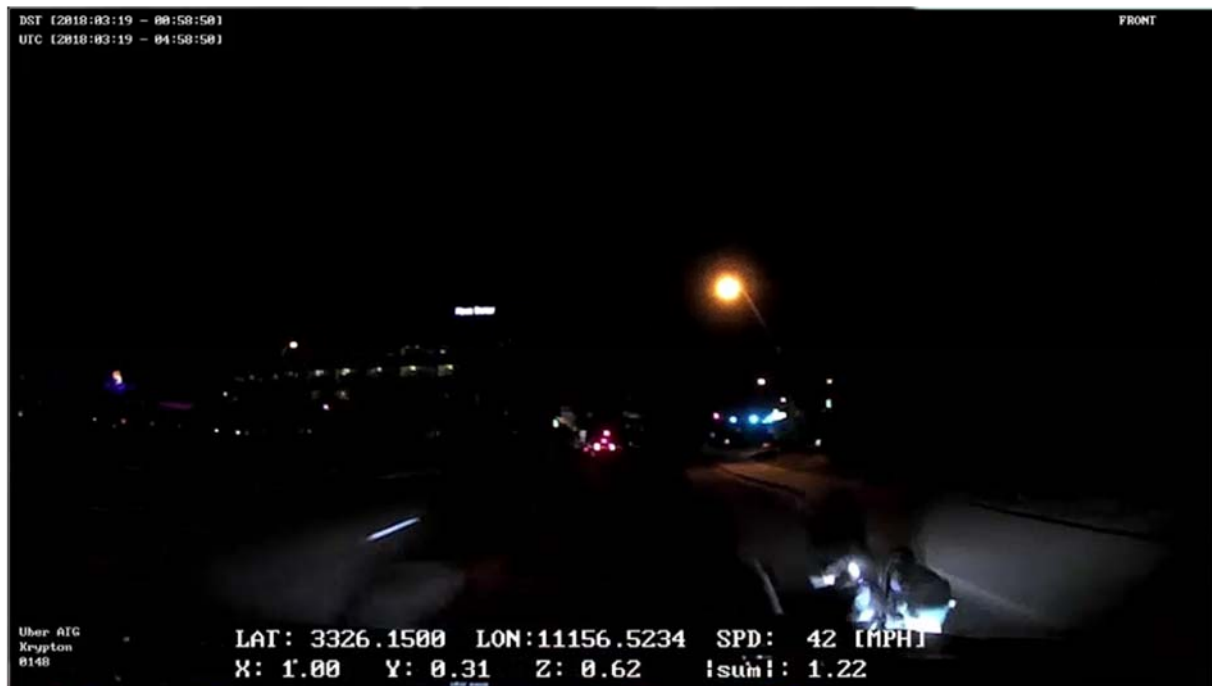
Illustration 11: Front camera image immediately after the impact

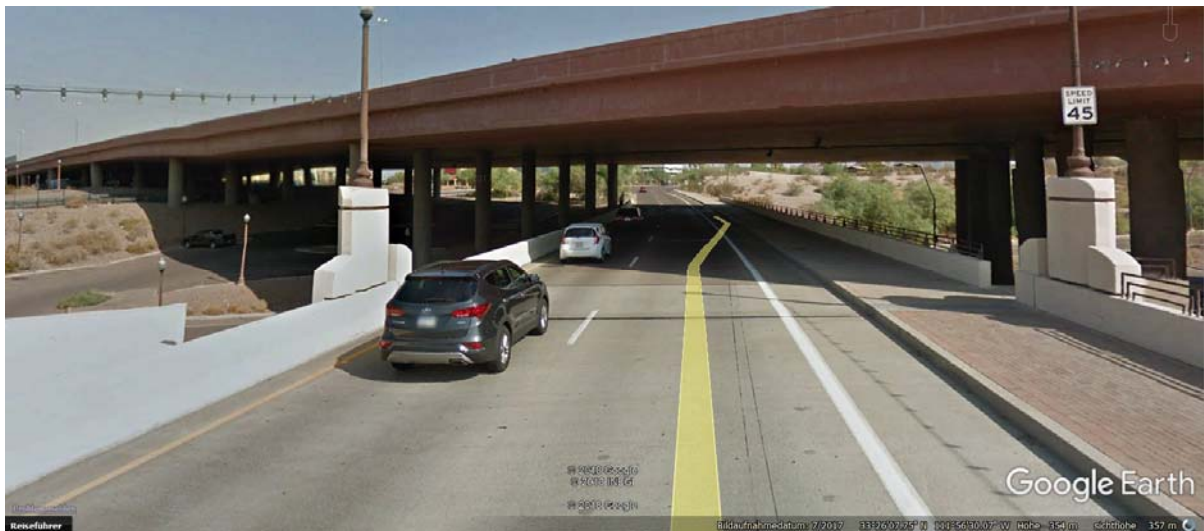
Illustration 12: Google Streetview Shot of the 45 mph sign by day

On the one hand, Google Earth provides in the Streetview view a completely clear picture of the signage in front of the bridge (about 200 m before the accident point). The picture is from July 2017 (well before the time of the accident).

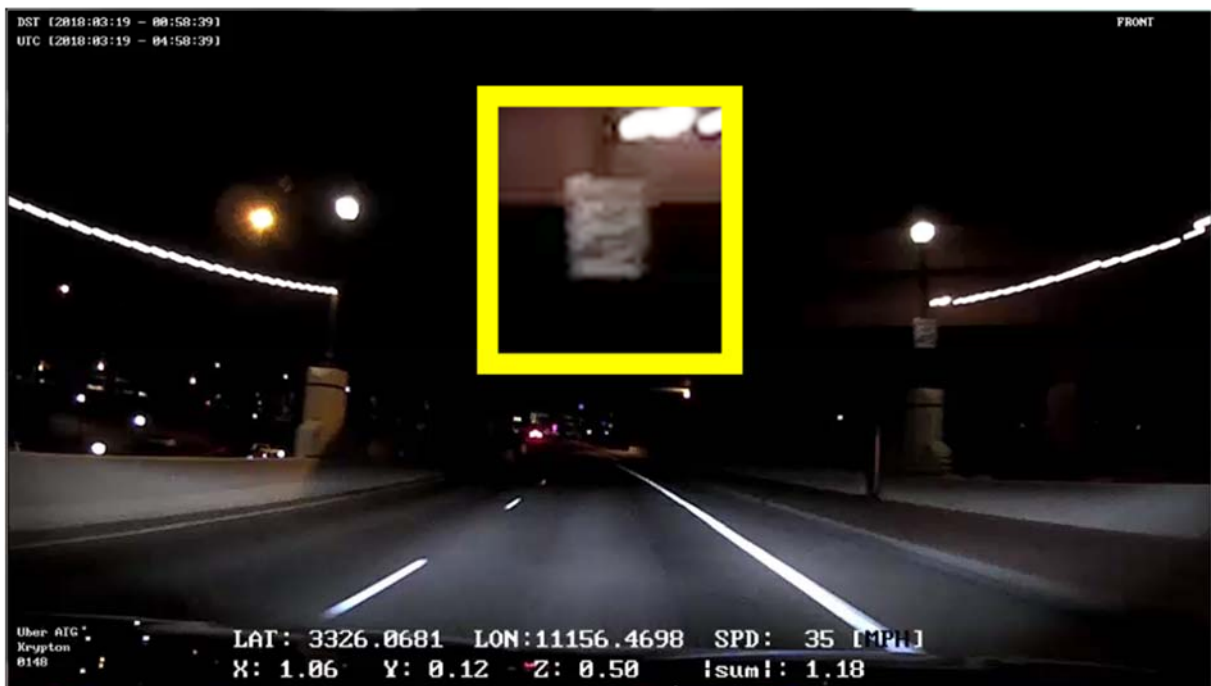
However, even on the accident video, the 45 mph sign is easily recognizable:

Illustration 13: Recording of the 45 mph shield from the accident car

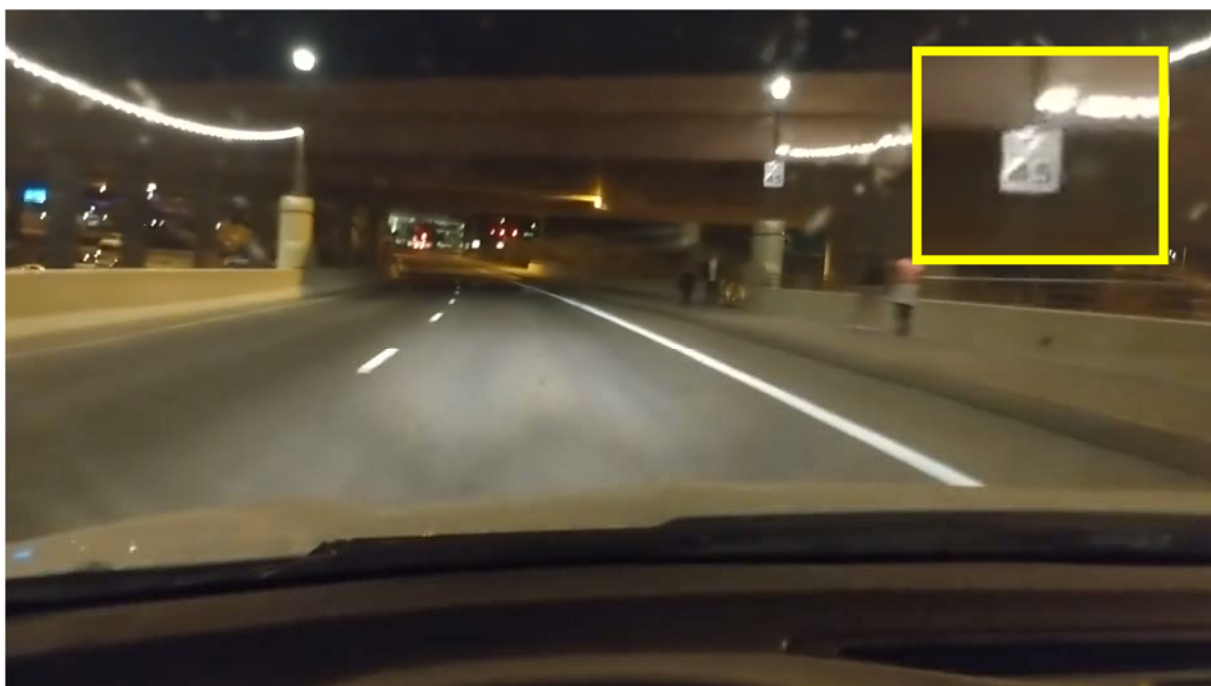
Moreover, on another on-the-internet video of the situation at night (recorded on March 21, 2018 by Brian Kaufman you can see the 45 mph limitation¹⁵.

Illustration 14: Shot of the 45 mph shield from a reference vehicle at night.

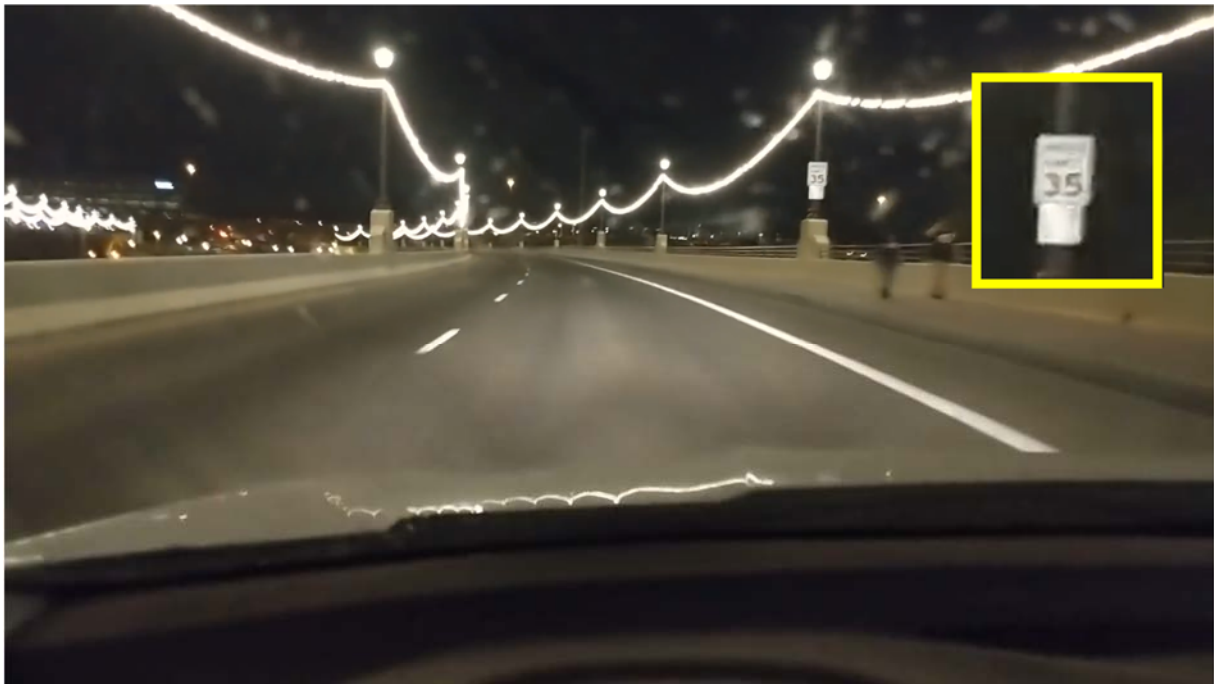
From the same video, you can also see at the beginning of the ride that there is a 35 mph limit several hundred meters before the bridge crossing:

Illustration 15: Take the previous 35 mph shield from the reference vehicle at night

Since this video also shows the area behind the accident, it becomes clear that after the 45 mph limit to the accident, there is no new deviating speed limit. This proves that there was a limit of 45 mph at the scene of the accident and not, as many erroneously claimed, 35 mph.

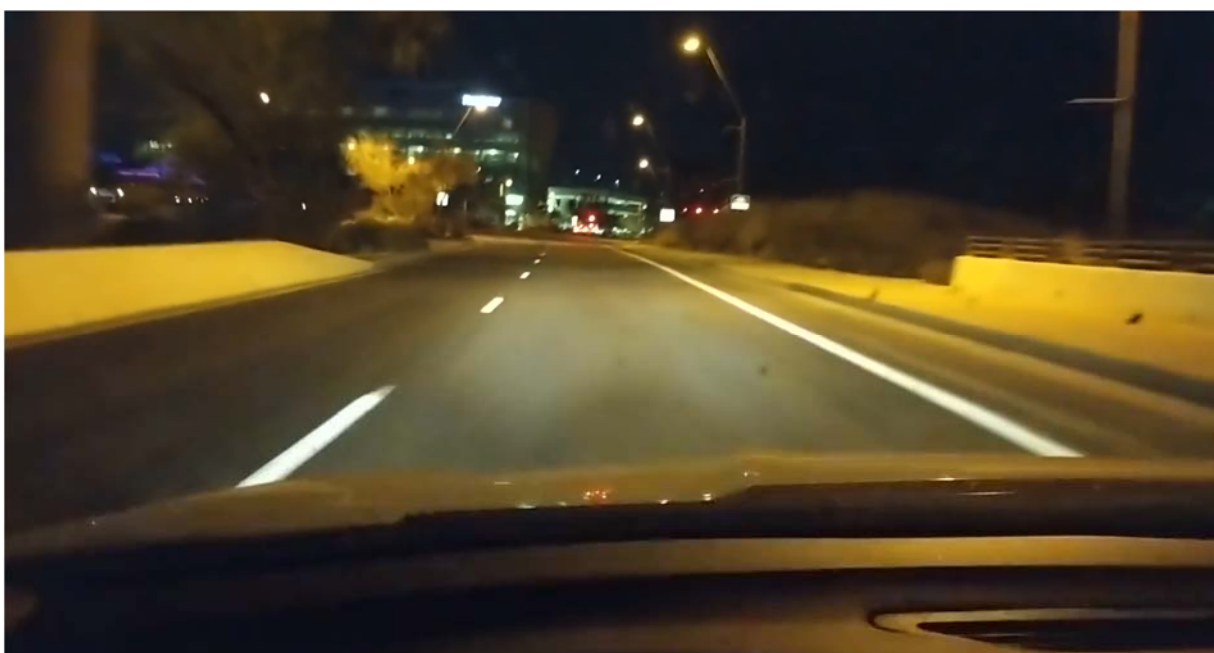
However, the video by Brian Kaufmann provides a much more important insight. The visual situation at night is not nearly as dark as the video broadcast by the police shows:

Illustration 16: Actual light situation at the accident site at night about 120 m before the accident

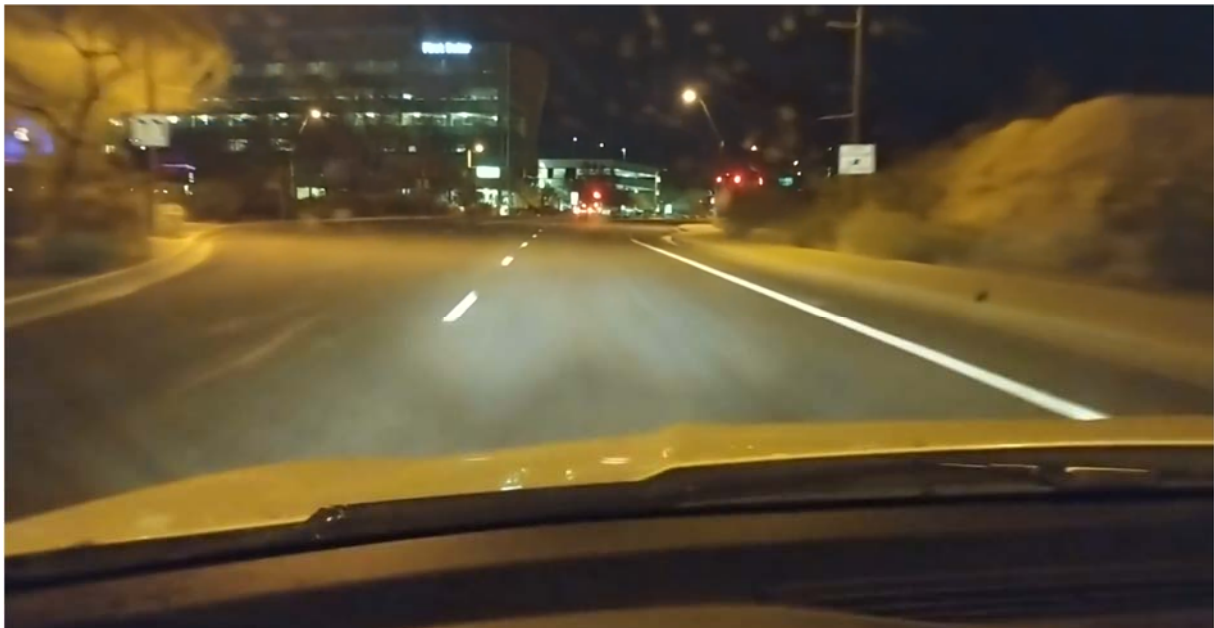
Illustration 17: Actual light situation at the accident site at night approx. 40 m before the accident

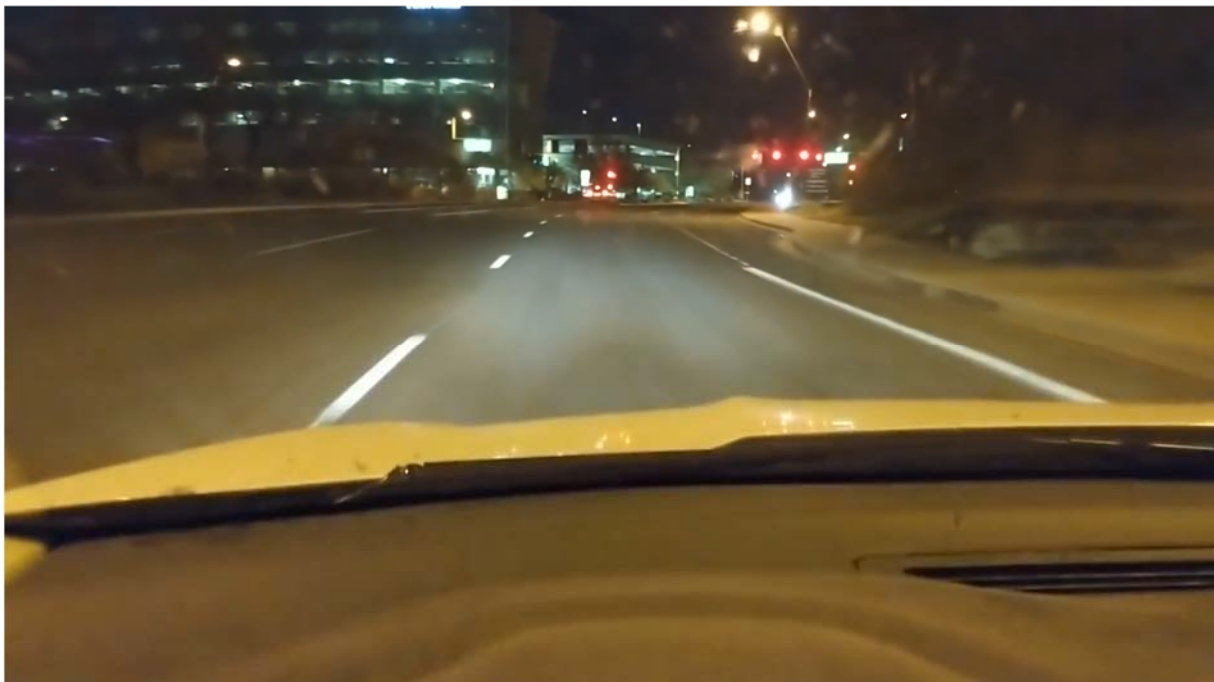
Illustration 18: Actual light situation at the scene of the accident

It can be clearly seen that the entire street is very well lit and an obstacle, such as a person crossing a bicycle pushing a bicycle would be easily recognizable.

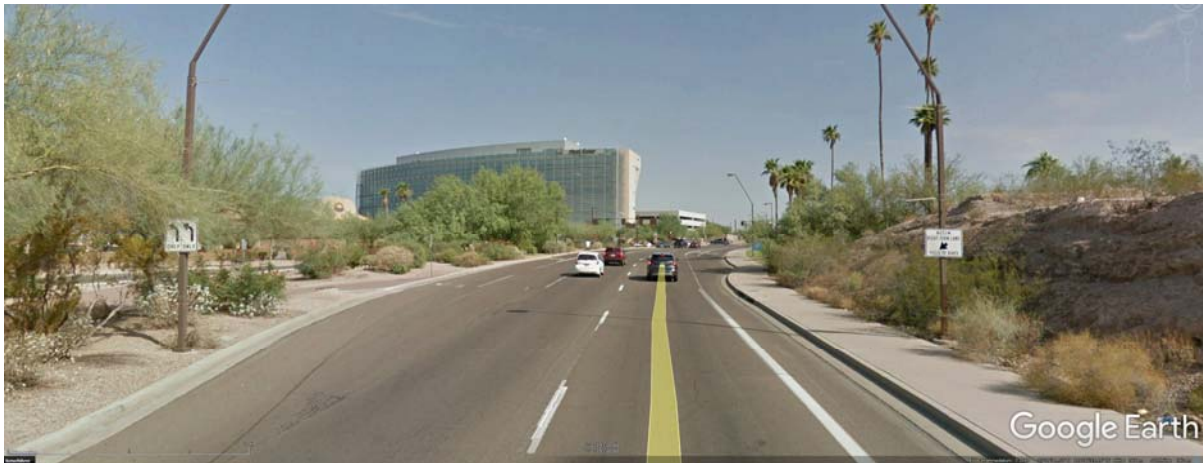
Illustration 19: Accident site by day (Google Streetview)

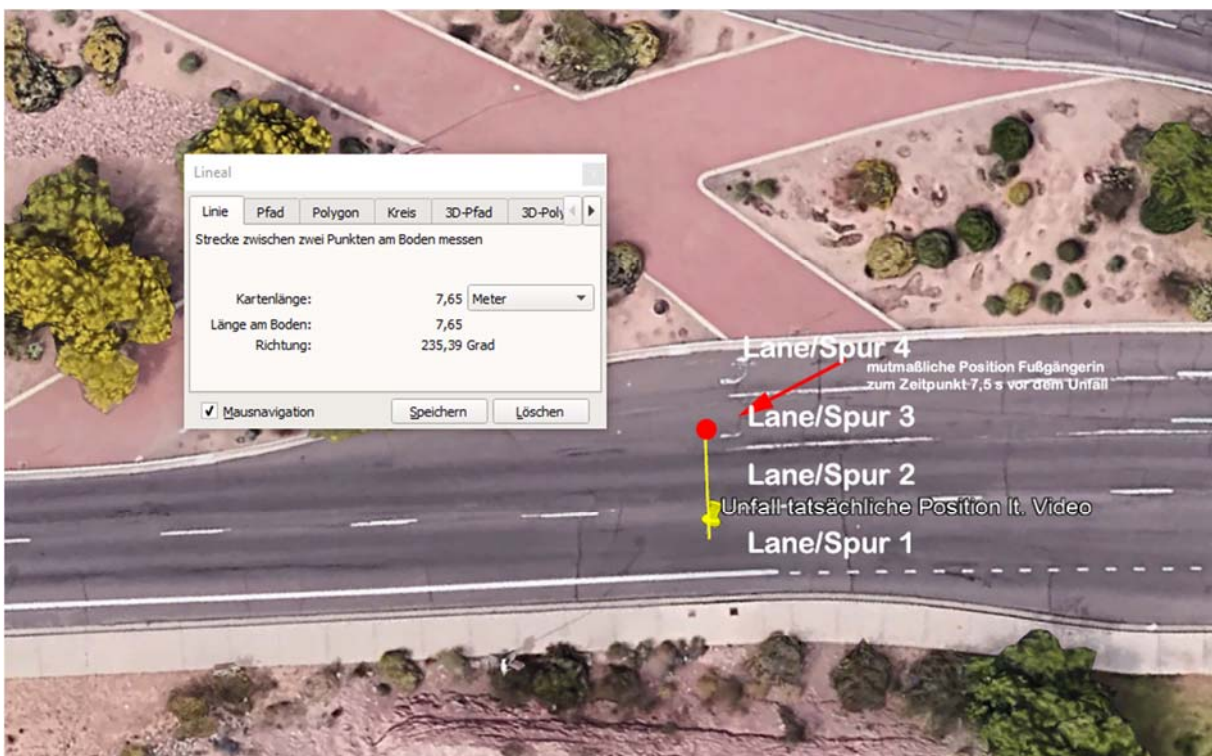
The video shows that she makes three steps from left to right in the right lane (lane 1) during this time. This corresponds approximately to a distance of 2.1 m (0.7 m per step). Thus, the accident victim moves with $v = 2.1 \text{ m} / 1.5 \text{ s} = 1.4 \text{ m} / \text{s}$. Extrapolating this speed to the period before becoming visible in the direction to the left (from where it was presumed to come from), it has about 2.8 m (lane 2) 3 s earlier and about 5.6 m (lane 3) further to the left.

Illustration 20: Calculated movement of the pedestrian across the lanes

Therefore, the woman was already on the road at least 7.5 seconds before the impact. The vehicle was at the time of the worst-case 45 mph = 72.42 km / h = 20.12 m / s fast. Thus, it was located 7.5 seconds before the impact about 150 meters from the scene of the accident. This point is under the bridge:

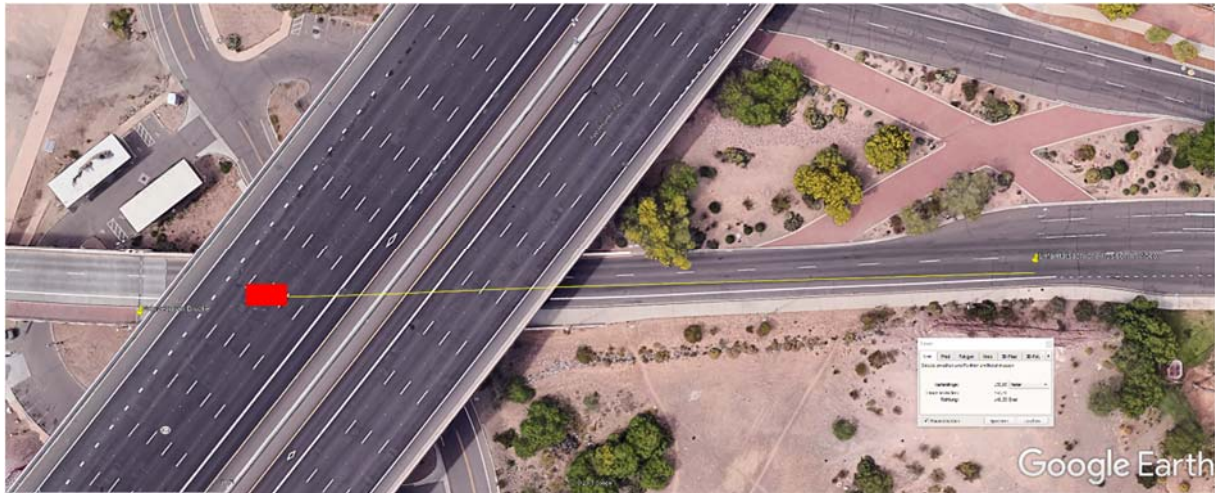
Illustration 21: Overview of the accident site via Google Earth

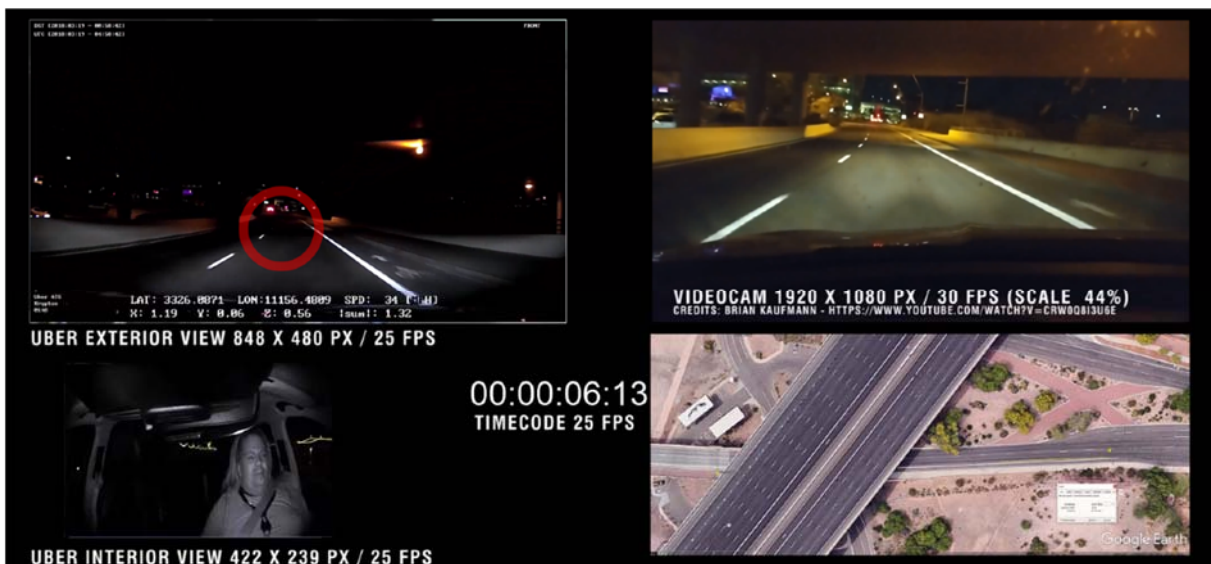
From the composite animation of the videos you can see that the driver of the Uber vehicle before the accident exactly at this point (time code 00:00:06:13) looked at the road for the last time and then did not look up until just before the impact.

Illustration 22: Composite and synchronized video presentation

The brighter comparison video shows that at that time the area of the turn lanes to the left of the main lanes was neither visible to sensors such as a LIDAR nor to a human driver. The woman was actually still in the shade of sight at this time.

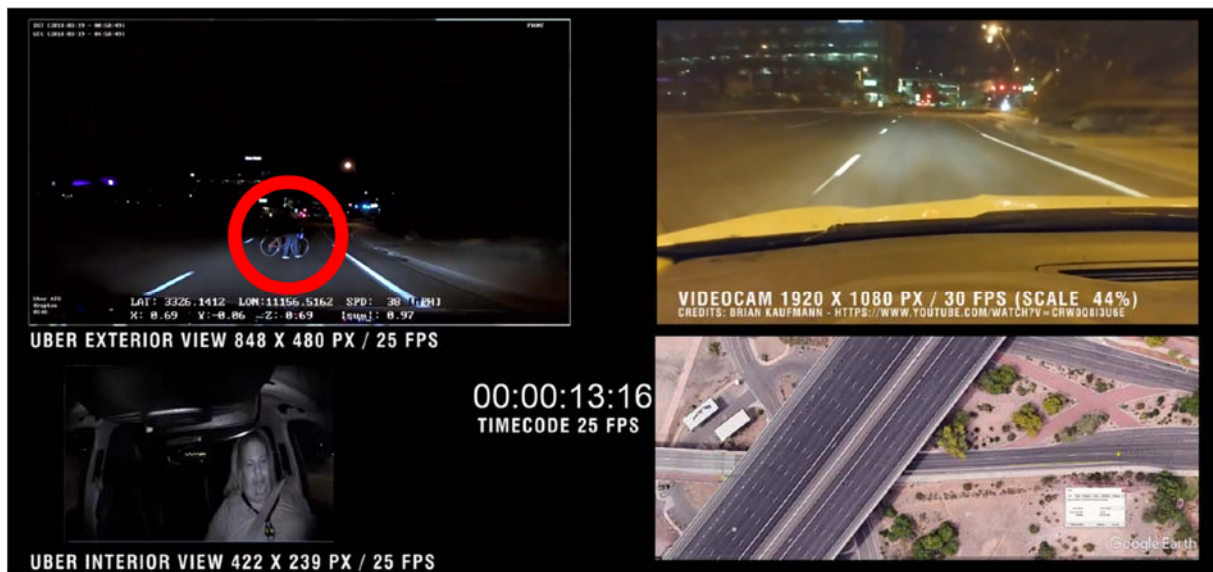
In fact, the human driver first looked at the roadway a second before the impact and used up the entire one-second reaction time allowed to a human driver until a reaction was made.

Illustration 24: Synchronized video presentation at the time just before the accident

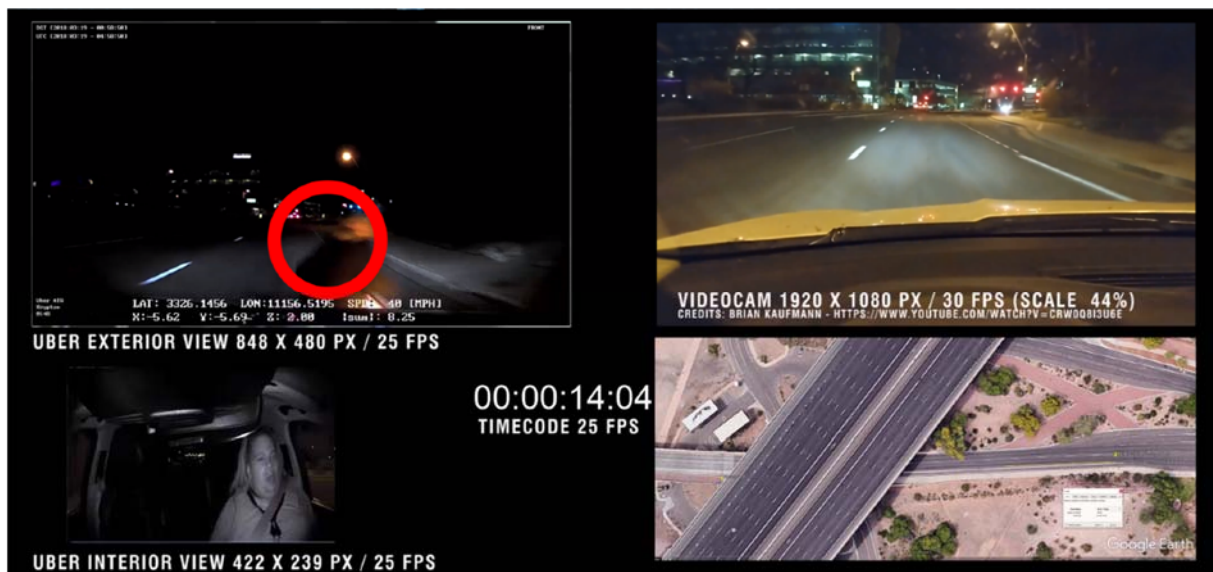
The impact is documented about 1 second later with time code 00:00:14:04.

Illustration 25: Synchronized video presentation at the time of the impact

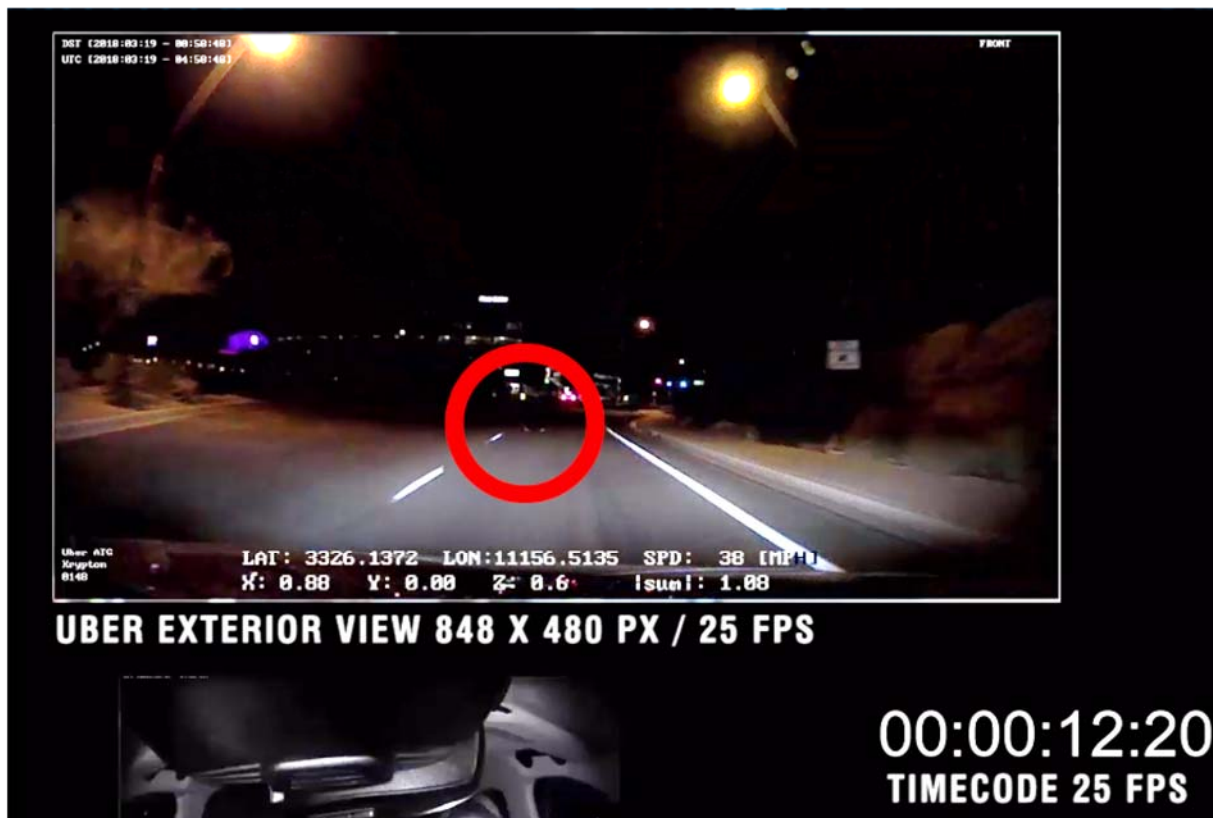
At latest at time code 00:00:12:20 and thus 1.4 seconds before impact, the victim is also visible in the dark video of the Uber vehicle and definitely in the detection range of the sensors themselves of a today in modern vehicles usual front collision warning on radar and / or camera base.

Illustration 26: Latest time to become visible in the police video

1.4 seconds before the impact, the vehicle still had a distance of at least 28 m to the accident victim. This would have led to an evasive maneuver against the direction of the woman and with a simultaneous braking to a pure braking distance of about 33.7 m. The residual velocity in a 28 m impact would have been just under 30 km / h instead of 72 km / h, resulting in less than a quarter of the impact kinetic energy. Possible meadow alone would have prevented the pedestrian from being fatally injured.
